TECHNICAL SERVICE BULLETINS

2/24/89

TECHNICAL SERVICE BULLETIN

ERROR CODE INFORMATION FOR ALL SOFTWARE THRU 4.00.00

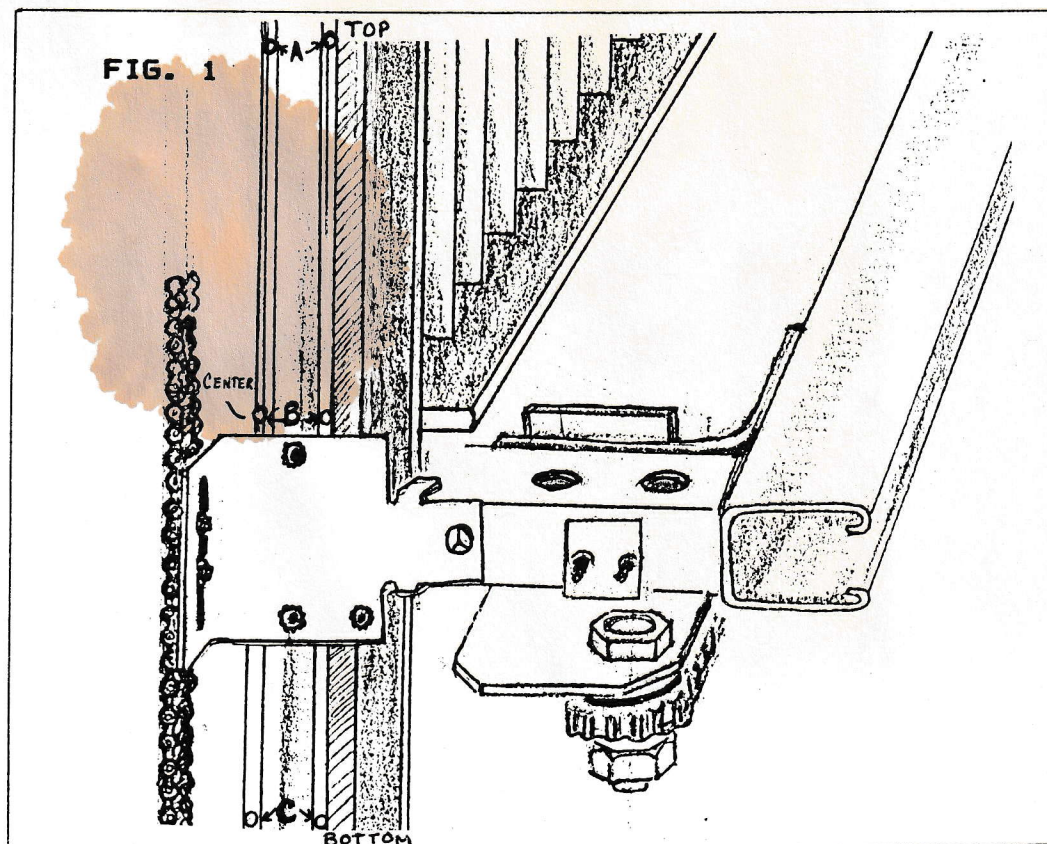
We recommend that you periodically clean the vertical support rails and the horizontal transport rail (See Parts Manual pg. 12 item 10) of any loose flaking or chipped galvanized coating in the area where the roller bearings run on the rails. Lightly sand down if particularly rough.

Apply a light coat of WD-40 oil on the rails and WIPE IT OFF. Put a small amount of Teflon grease in the three places on each vertical rail (as indicated in FIG. 1 A, B & C) and allow the Vendor to work the grease in as it rents tapes under normal operation. CAUTION the Teflon grease must go ONLY on the outer, rolled edge of the rail channel where it comes in contact with the white, plastic Wear Plate (See Parts Manual pg. 12 item 16).

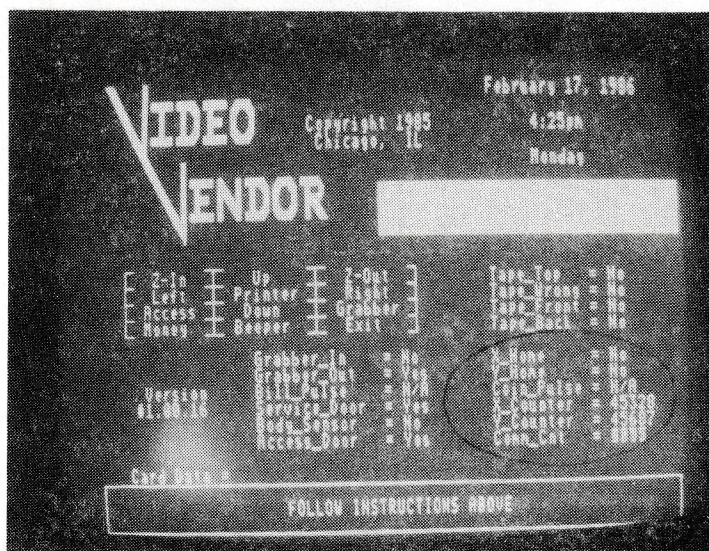
PHOTO (1)

DISPLAYED ON THE SCREEN WILL BE ALL OF THE ENCODER INFORMATION WE WILL NEED TO TEST FOR X-HOME AND Y-HOME CONDITIONS AND FAULTS.

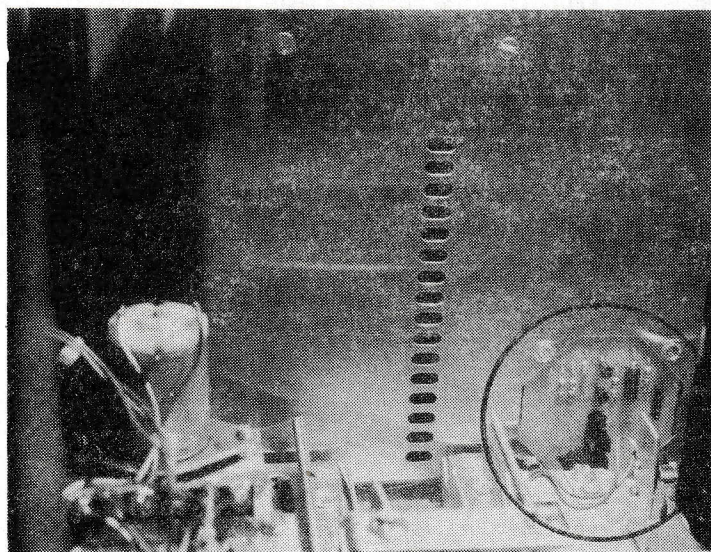
PHOTO (2)

BEFORE BEGINNING THE INTERRUPTER TESTS AS DESCRIBED BELOW MAKE CERTAIN THAT THE PLASTIC INTERRUPTER IS IN FACT ENTERING THE BLACK -U-SHAPED HOME ENCODER. [SEE PHOTO (2)] . TO VIEW THE X-HOME ENCODER IT IS USUALLY NECESSARY TO REMOVE THE TAPE CARRIER TRANSPORT COVER IN ORDER TO SEE THE INTERRUPTER ENTER THE BLACK INFRA-RED HOME DETECTOR...BUT...WHEN YOU REMOVE THE COVER THE SYSTEM MAY NOW APPEAR CORRECT; THAT IS THE PLASTIC INTERRUPTER ENTERS THE U-SHAPED DETECTOR, WHEN YOU PUT THE COVER BACK ON THE SYSTEM FAILS....CAREFUL EXAMINATION MAY SHOW THAT THE INTERRUPTER IS JUST BARELY ENTERING THE LOWER EDGE OF THE HOME DETECTOR WITHOUT THE COVER ON. THE ADDED WEIGHT OF THE COVER AND A TAPE LOWERS THE ASSEMBLY JUST ENOUGH TO CAUSE THE INTERRUPTER TO HIT THE DETECTOR AND BE DEFLECTED ...SOLUTION---MAKE SURE THE INTERRUPTER ENTERS THE CENTER OF THE DETECTOR. CAUTION; DO NOT BEND THE PLASTIC INTERRUPTER TO MAKE THE ADJUSTMENT. THE ENCODER BOARD IS MOUNTED WITH 4-SCREWS AND THEY ALLOW FOR VERTICAL ADJUSTMENT. LOOSEN THE SCREWS SLIGHTLY AND PRY GENTLY UP OR DOWN ON THE BOARD EDGE TO SHIFT THE BOARD TO THE REQUIRED POSITION.

showing the plastic interrupter entering the x- home encoder

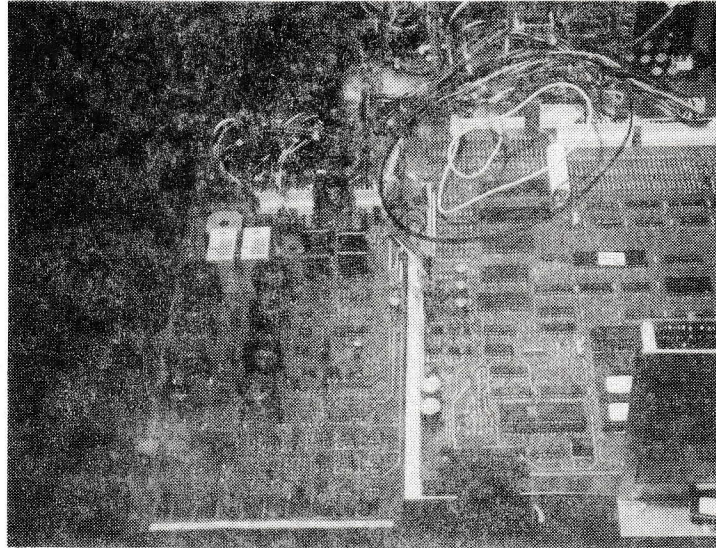
PHOTO (5)

showing pins #1 and #8 jumpered together on the J4 connector

IF THE DISPLAY NOW SHOWS -NO THEN YOU WILL HAVE TO LOOK FOR A SHORT TO GROUND IN THE CABLE SET. IF THE DISPLAY WAS CONTINULY SHOWING -NO THEN TRY SHORTING THE 1ST AND 8TH PINS TOGETHER SEE PHOTO (). THIS SHOULD PRODUCE A -YES- ON THE DISPLAY IF IT DOES THEN THE PROBLEM IS IN THE CABLE YOU WILL HAVE TO LOOK FOR A DEFECTIVE CABLE...BROKEN LEAD OR MORE LIKELY A BAD CONNECTION IN ONE OF THE PLUGS. IF THE DISPLAY STILL DOES NOT SHOW YES THEN THE PROBLEM LIES IN THE MAIN PROCESSOR BOARD.

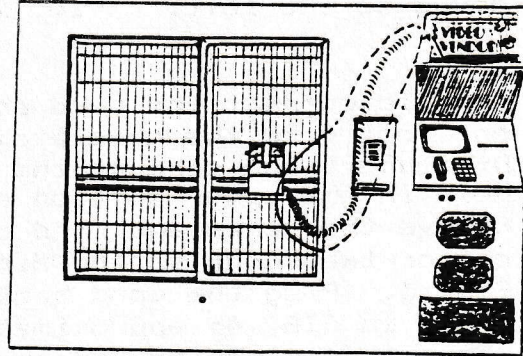
The long coiled cord used on the tape transport can get jammed at the access door, under certain conditions, and cause the Vendor to blow the fuse on the motor controller board. It would be beneficial to check the cords on all Vendors and correct the hanging of the cord if it is found to be incorrect.

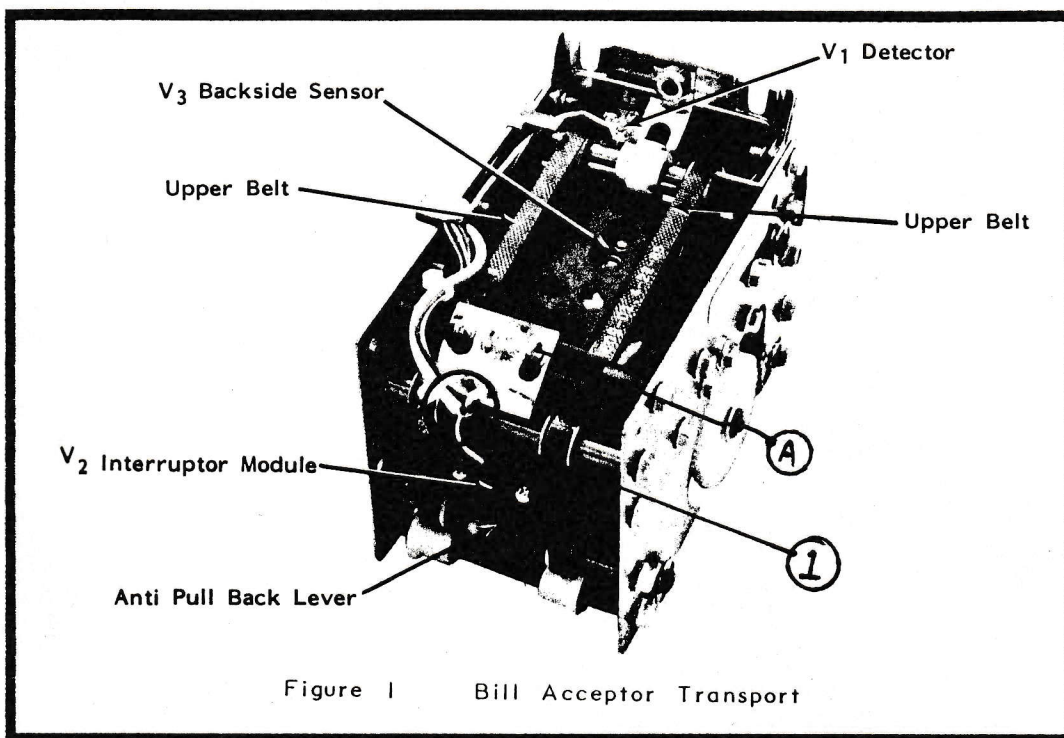
Figure 1 Bill Acceptor Transport

#1 POINTS TO THE SHIELDED GREY COVERED TWO WIRE CORD.
THE TWO BLACK WIRES INSIDE ARE CONNECTED TO THE P.C. BOARD (A)
IF THE SHIELD IS **STICKING OUT FROM AROUND IT'S PLASTIC COVER AND TOUCHES ANY PART OF THE METAL CASING OR COVER IT WILL PREVENT YOUR MACHINE FROM TAKING ANY MORE CURRENCY.**
